**ASSESSMENT OF HYDROCARBON INDUCED GROUNDWATER POLLUTION AND
IDENTIFICATION OF POLLUTANTS IN BARUWA COMMUNITY**

DEPARTMENT OF PETROLEUM ENGINEERING

COVENANT UNIVERSITY, OTA.

| AUGUST 2022 |

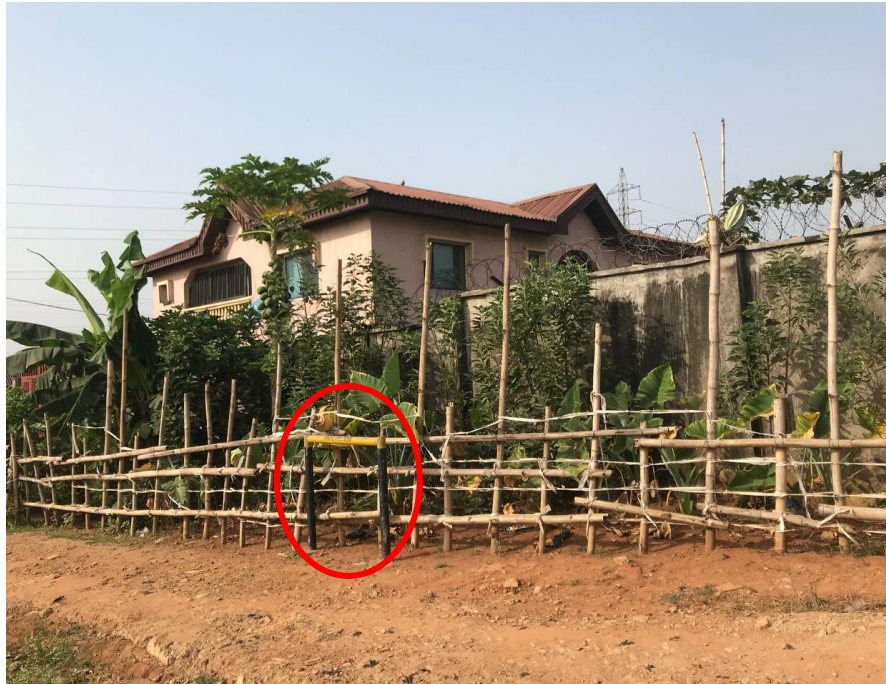
Figure 1.4: NNPC ROW indicator just beside a farm in Baruwa

A number of neighborhoods in Lagos are at risk of losing access to safe ground and surface water due to the presence of hydrocarbons from pipeline leakages. The Baruwa community in Lagos state is one of these impacted locations. The community is traversed by several NNPC/PPMC pipelines running underneath. NNPC PROW indicators can be seen around farms (Figure 1.4) and even residential buildings in the community (Figure 1.7).

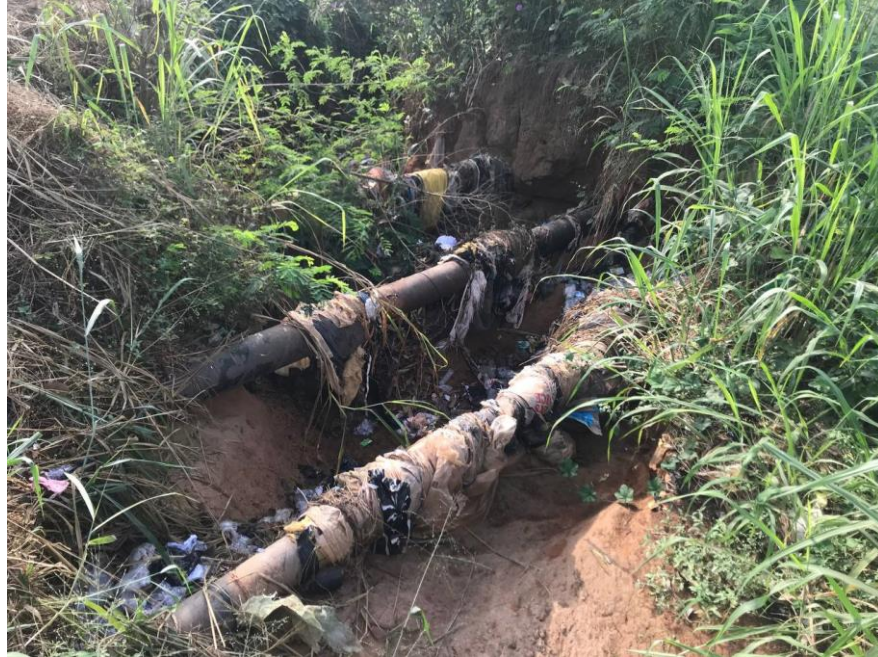
Figure 1.5: Exposed pipelines in Baruwa

In the Baruwa community of Lagos state, there is the presence of contamination of their groundwater resulting from hydrocarbon seepages from pipelines either damaged from deterioration due to ageing or vandalized by residents who siphon them for cash. As a result of this, majority of the residents cannot use the water from their wells or boreholes. The contaminated water has a distinct brown coloration in their water tanks (Figure 1.6) as well as other containers used to hold water such as their cups and buckets. The distinct brown coloration is due to the presence of iron, copper, zinc, and other trace metals present in gasoline (Santos, et al., 2011). Furthermore, the people are exposed to pipeline explosions resulting from these damaged and/or exposed pipelines (Figure 1.5).

Baruwa Community serves as our case study. The community lies between latitude $06^{\circ} 35' 12''$ North and $03^{\circ} 16' 21''$ East. It is located in Iyana-Ipaja in Lagos State, Southwest of Nigeria (Figure 1.1), between the renowned Iyana-Ipaja Bus Stop and the Ikotun Area of Alimosho Local Government Council (Figure 1.2). Iyana-Ipaja Bus Terminal is approximately 2.5 kilometers away, and the community is bordered on the right and left by Gowon Estate and Abesan Estate, respectively. The area has a steeping topography (Figure 1.3) and is prone to erosion which leaves buried pipelines exposed as is seen in Figure 1.5.

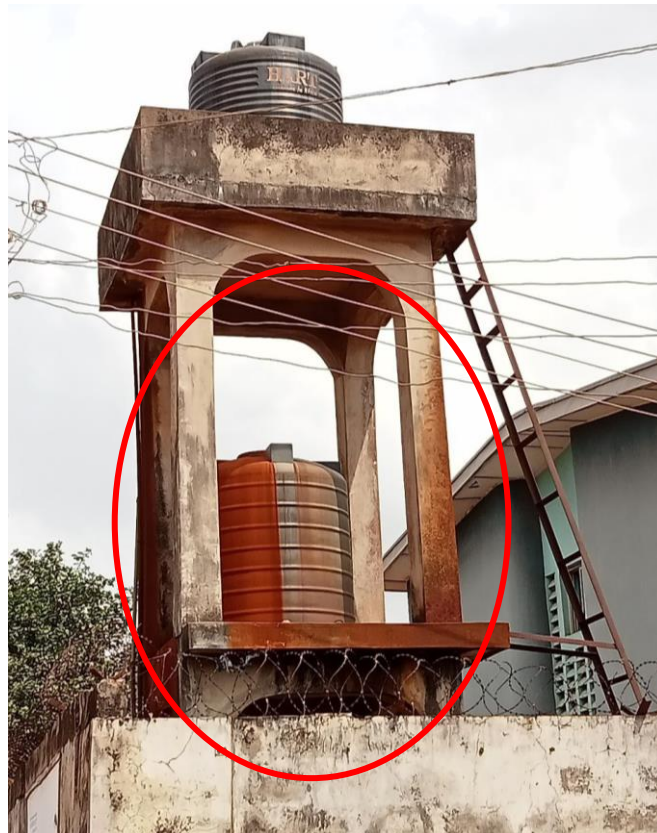
Figure 1.6: Evident water contamination in water tanks

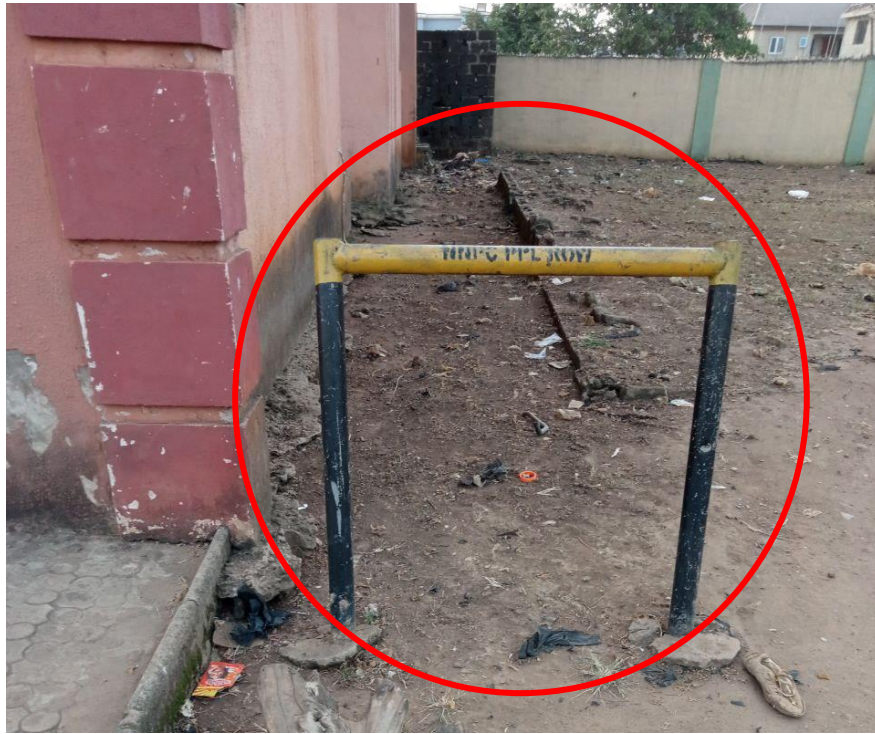
Figure 1.7: NNPC pipeline row indicator just beside a residential building in Baruwa

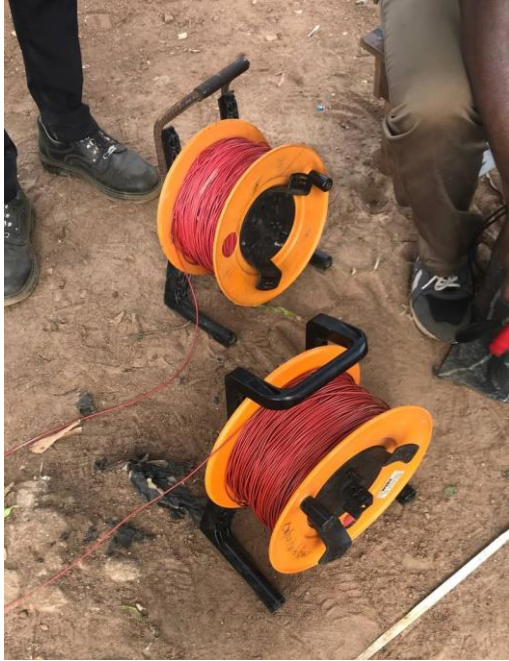
Figure 3.1: Cable reels

- a. Cable reels (Figure 3.1)
- b. Steel rod electrodes (Figure 3.7)
- c. 4 1000kg hammers (Figure 3.2)
- d. Garmin GPSMAP 78 Handheld Marine GPS Device (Figure 3.3)
- e. ABEM (Signal Averaging System, SAS4000) Terrameter (Figure 3.4)
- f. Logix 12-volt battery (Figure 3.5)
- g. Surveyor measuring tape (Figure 3.6)

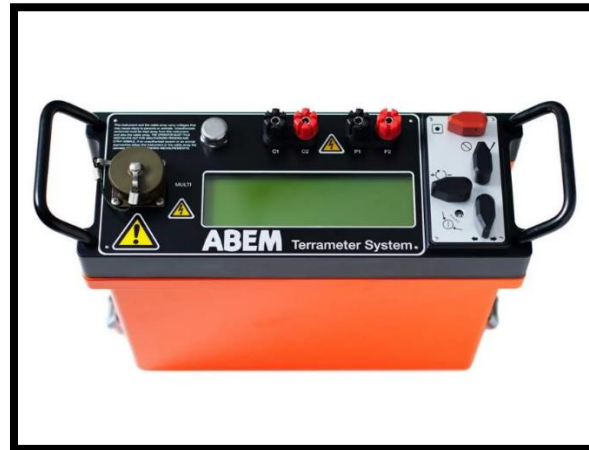
Figure 3.4: ABEM SAS4000 Terrameter

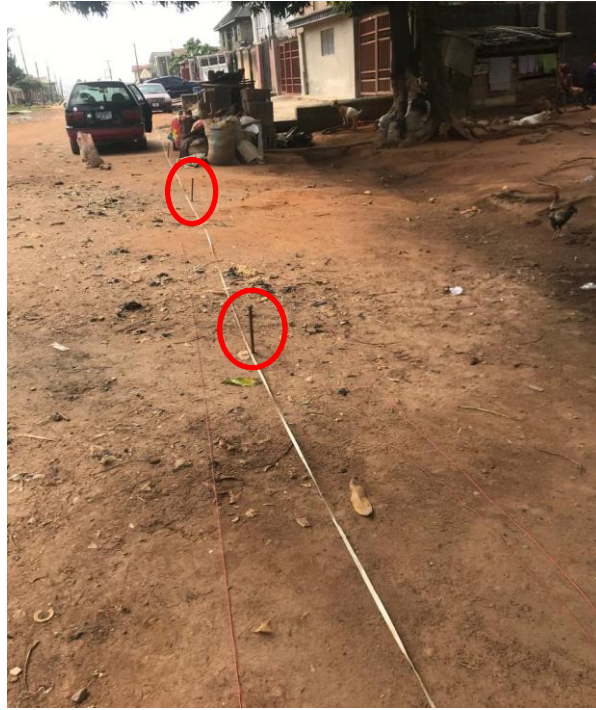
Figure 3.7: ERT traverse for Profile 1 (steel electrode rod indicated by the red circle)

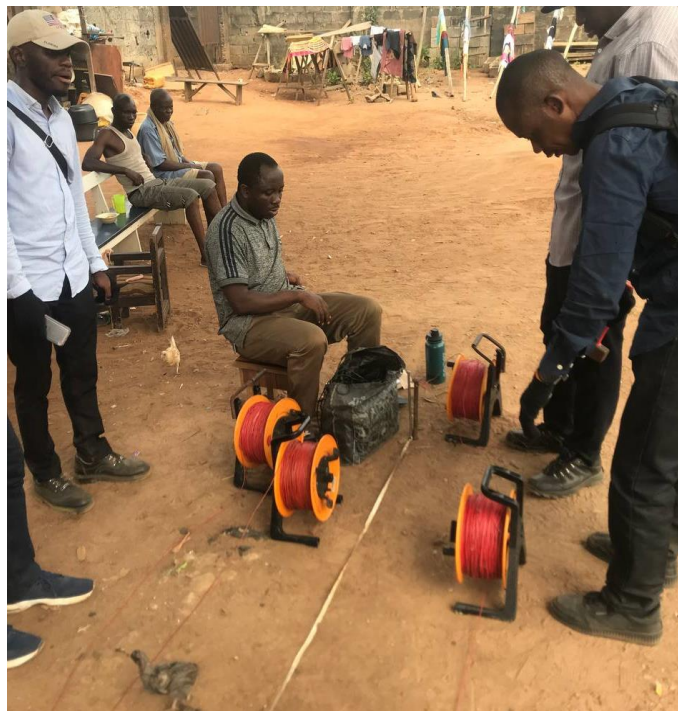
Figure 3.8: Base station set up for ERT Traverse 1 (Road 1)

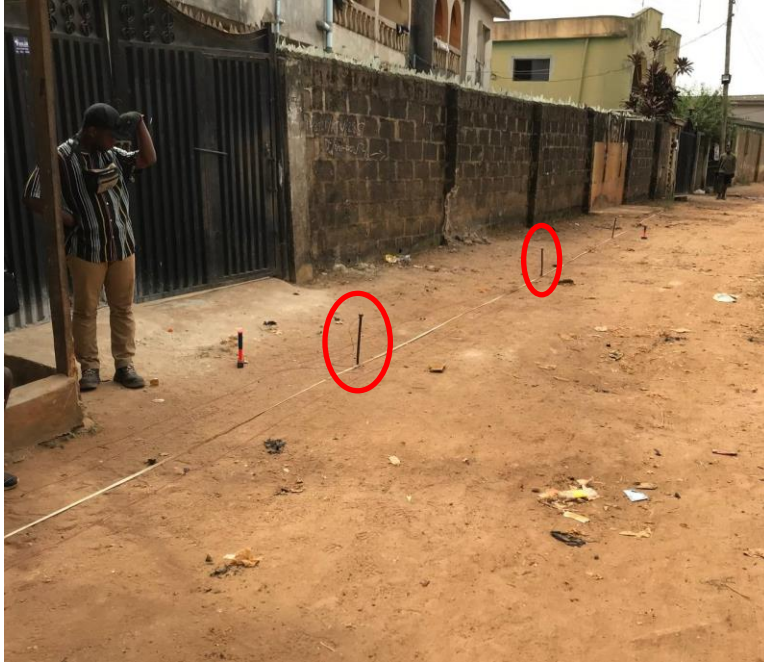
Figure 3.9: ERT traverse for Profile 2

The second ERT base station was located at N 06° 35' 00.0" and E 003° 16' 21.5" as shown in Figure 3.10 (with an elevation of 45 m) and ran through till N 06° 35' 02.5" and E 003° 16' 15.8" (with an elevation of 47 m). A traverse of 200 m was carried out along “Aduloju Street” of the Baruwa community. Figure 3.9 shows the ERT profile along this traverse and the GPS readings for six (6) points along the traverse are presented in **Error! Reference source not found.** .

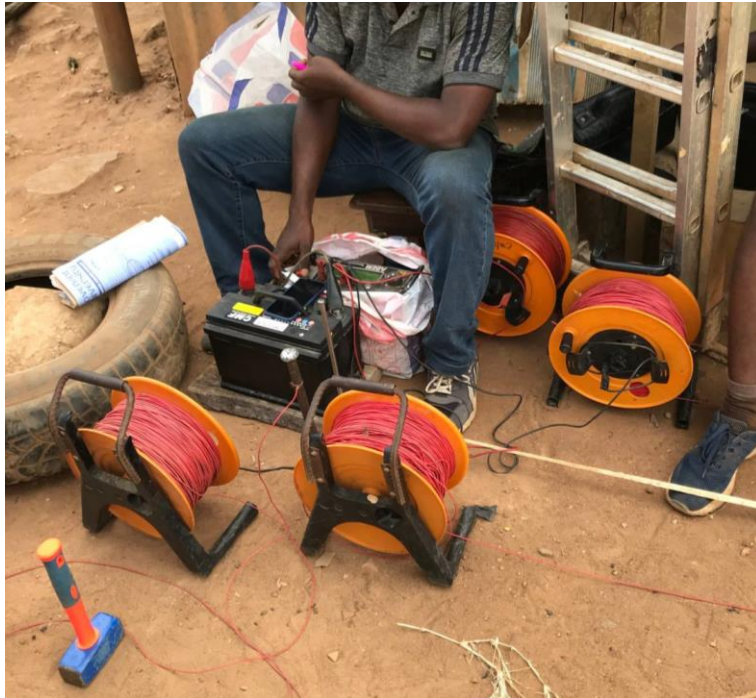
Figure 3.10: Base station set up for ERT traverse Profile 2 (Aduloju street)

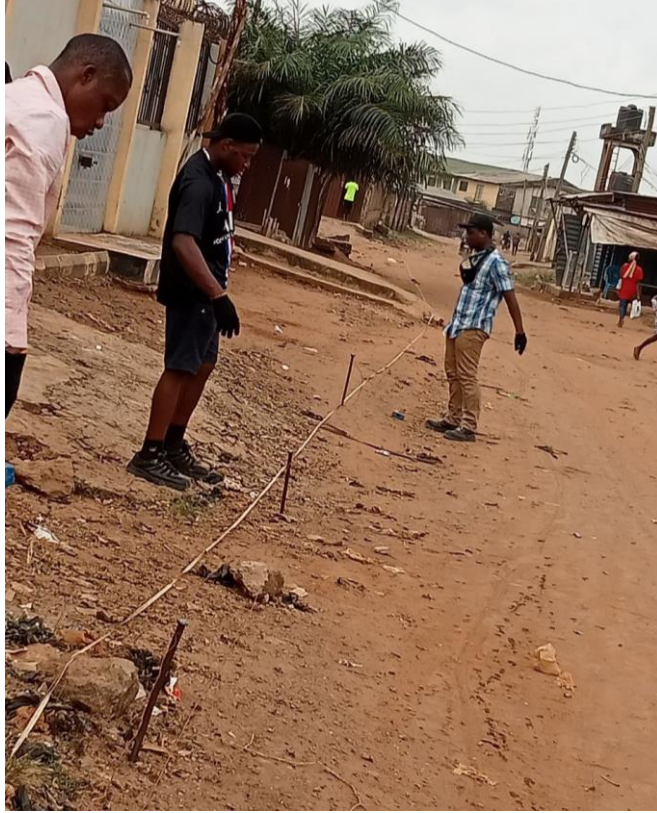
Figure 3.11: ERT traverse for Profile 3

The third ERT base station was located at N 06° 35' 52.7" and E 003° 16' 20.7" as shown in Figure 3.12 (with an elevation of 53 m) and ran through till N 06° 35' 54.3" and E 003° 16' 14.6" (with an elevation of 40 m) as is captured in Figure 3.11. The traverse, spanning 200 m, was carried out along “Church Street” of the Baruwa community, with Figure 3.11 showing the ERT profile along the traverse and the GPS readings for every 5 m along the traverse is shown in Table 3.3.

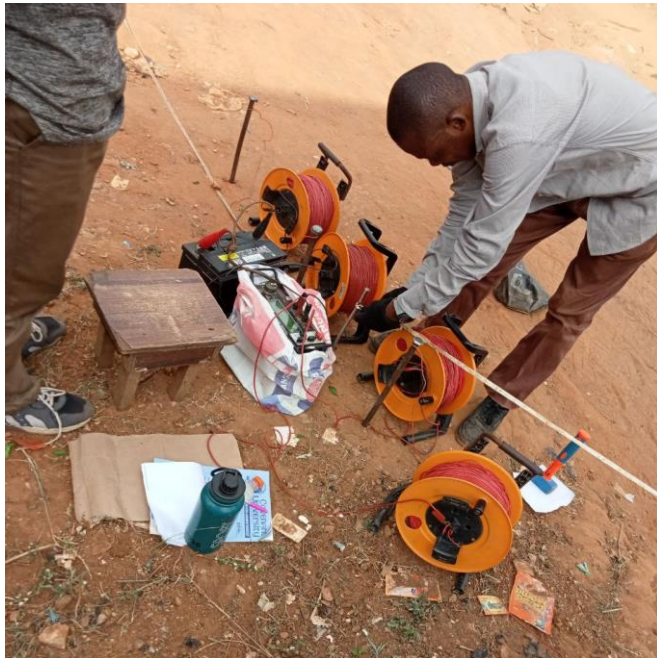
Figure 3.12: Base station set up for ERT traverse profile 3 (Church Street)

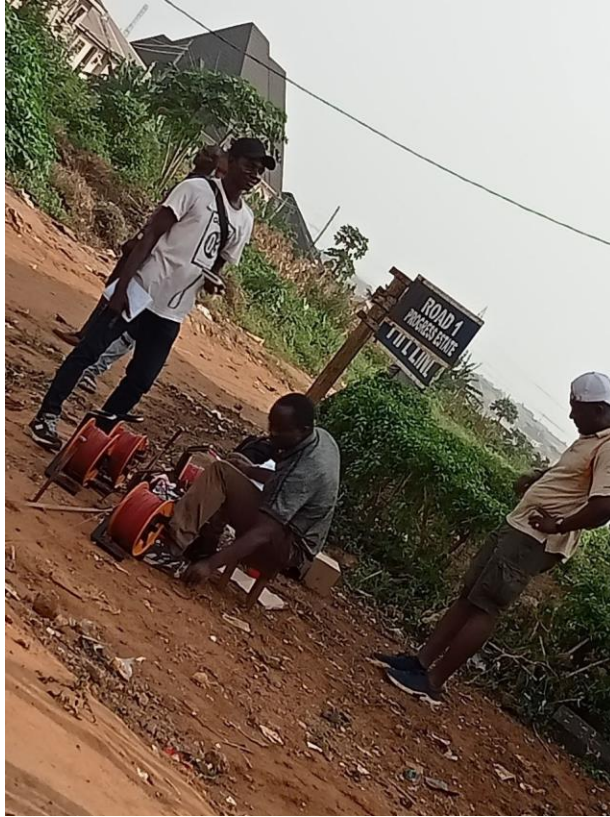
Figure 3.13: Base station set up for VES survey

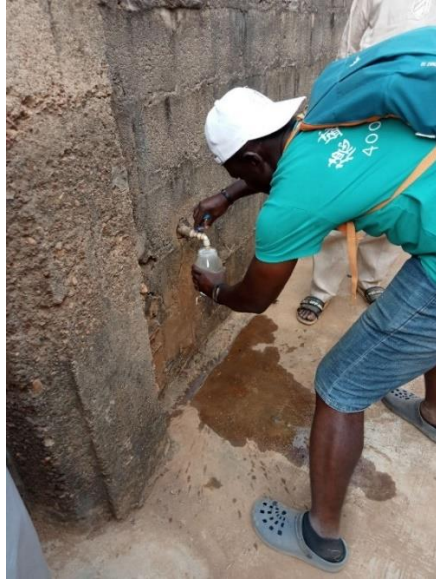
Figure 3.14: Water sample being collected from local resident's tap

Water samples were collected from water sources used by local residents which included taps and wells. A total of fifty (50) different locations were visited and a water sample was retrieved from each location, hence, a total of fifty (50) water samples were collected. Each sample was stored in a 946 ml glass jar with a plastic lid and sealed properly. Sample jars were adequately labelled according to the location where they were retrieved (see **Table 3.5** for GPS coordinates of each sample location).

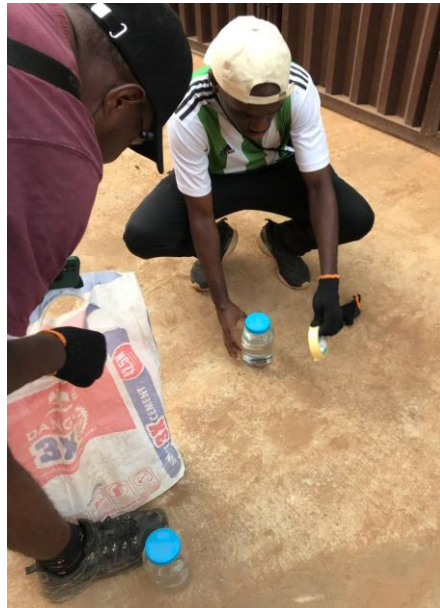
Figure 3.15: Water sample being labelled according to our sample location numbering

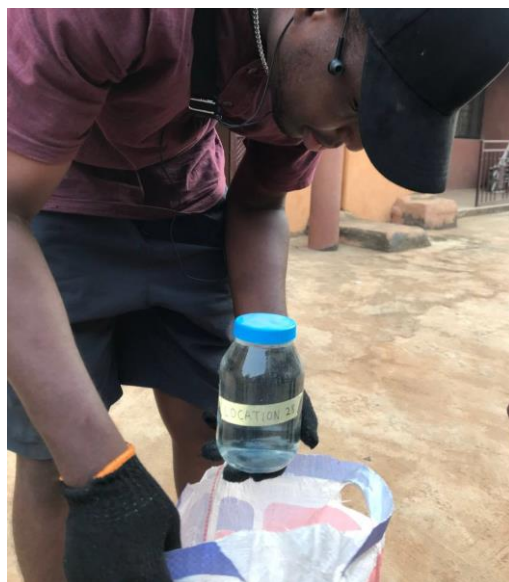
Figure 3.16: Water samples being brought together to be sent to the lab for physiochemical analysis

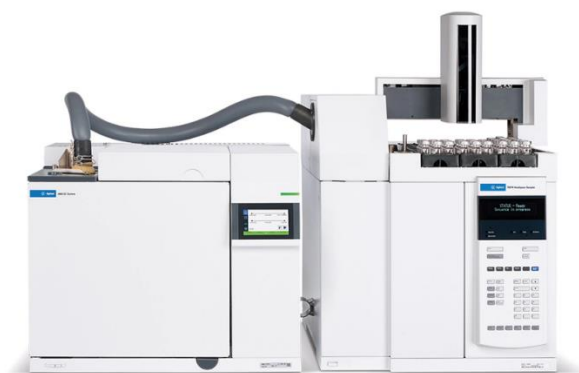
Figure 3.17: AGILENT 8860 GC-FID Coupled with 7697A Headspace Sampler

Instrument Used: Agilent 8860 GC-FID Coupled With 7697a Headspace Sampler (Figure 3.17).

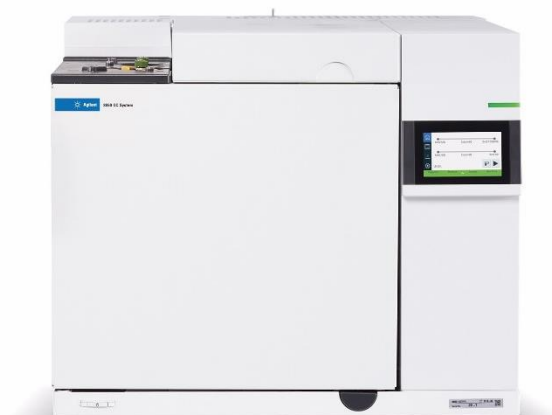
Figure 3.18: AGILENT 8860 GC-FID

Instrument Used: Agilent 8860 Gc-Fid (Figure 3.18)

Calibration Standards: Accustandard Hydrocarbon Window Defining Standard, 500mg/L (Catalog Number: Drh-008s-R2).

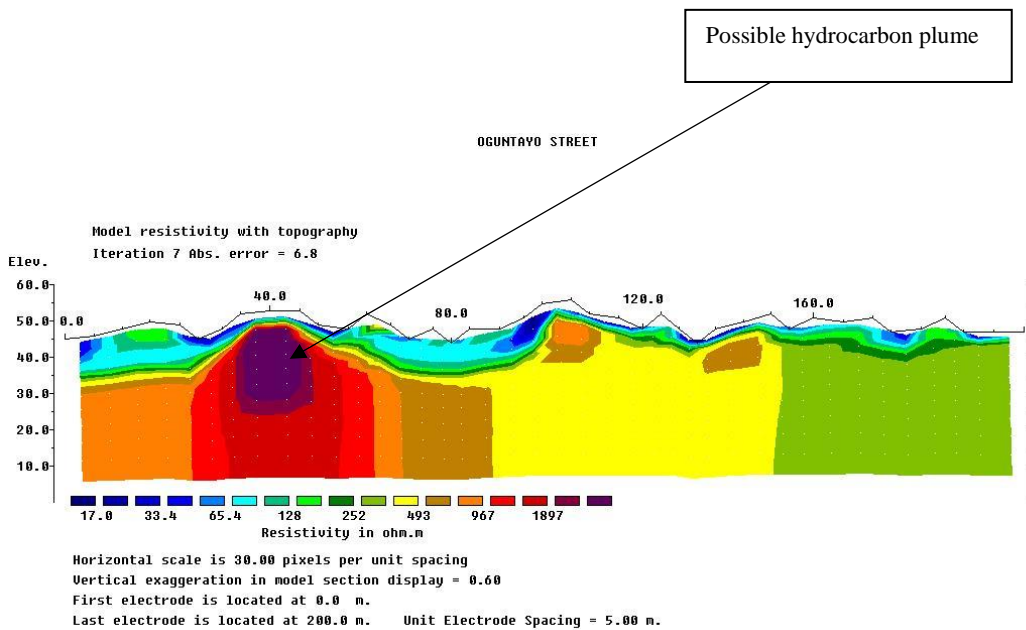
Figure 4.4 shows the Wenner array 2D resistivity of the subsurface structure in the investigated region. The 2D electrical resistivity imaging result show the resistivity distribution over a lateral distance of 200 m and to a depth of about 40 m from the surface. At a lateral distance of 25 – 60 m, anomalously high resistivity values (1500 – 4000 $\Omega\cdot\text{m}$) are recorded. The highest resistivity value occurs at a lateral distance of 38 – 50 m at a depth of 2 – 20 m beneath the surface. This is the depth at which the possible hydrocarbon plume is located. At a lateral distance of 25 – 60 m anomalously high resistivity values are still being recorded at depths between 20 – 40 m which indicates the likely spread of the hydrocarbon plume through the soil columns due to its permeability or the presence of flowing groundwater from an aquifer.

Figure 4.4: ERT profile for Oguntayo Street

Figure 4.2 and Figure 4.4 show the dispersal of the hydrocarbon contaminant plume, especially at depths between 25 – 40 m and correlating that with the geological section (see Figure 4.12), this dispersal or spreading of the contaminant plume is possibly due to the presence of flowing water from the main aquifer in the study area. This would mean that for wells located at the near surface depths (0 – 10 m), the concentration of the contaminant plumes will be higher than wells at greater depths where the plumes have dispersed to.

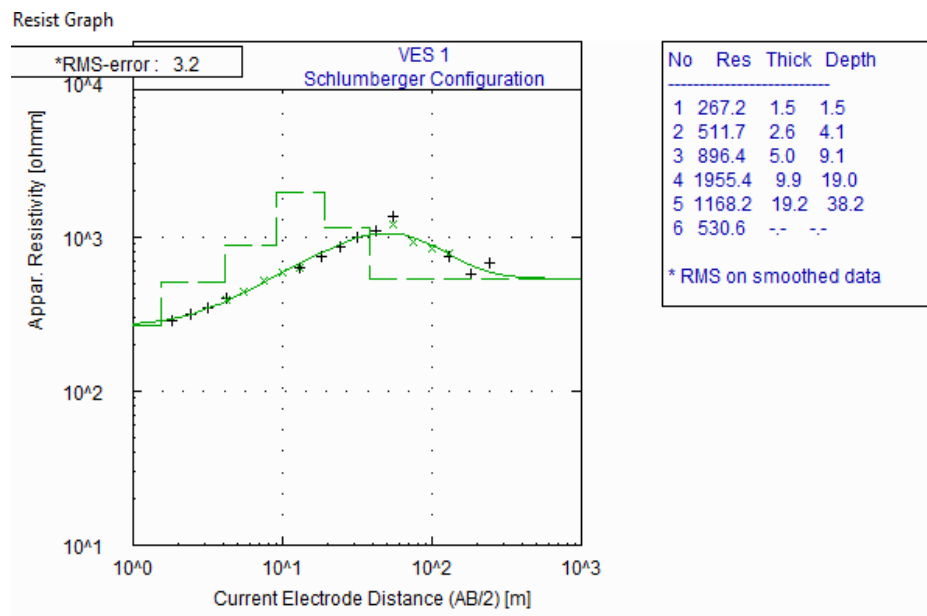
The traverse reveals a resistivity distribution ranging between 267.2 Ω and 1955.4 Ω (see Figure 4.5). Figure 4.5 also reveals the number of layers present in the subsurface as well as the resistivity, thickness, and depth of each layer. Six (6) layers were discovered, and the fifth layer was mapped out to be at a depth of 38.2 m. The type of curve for this profile is Type K.

Figure 4.5: VES 1 Profile (Goelectric-section for VES 1)

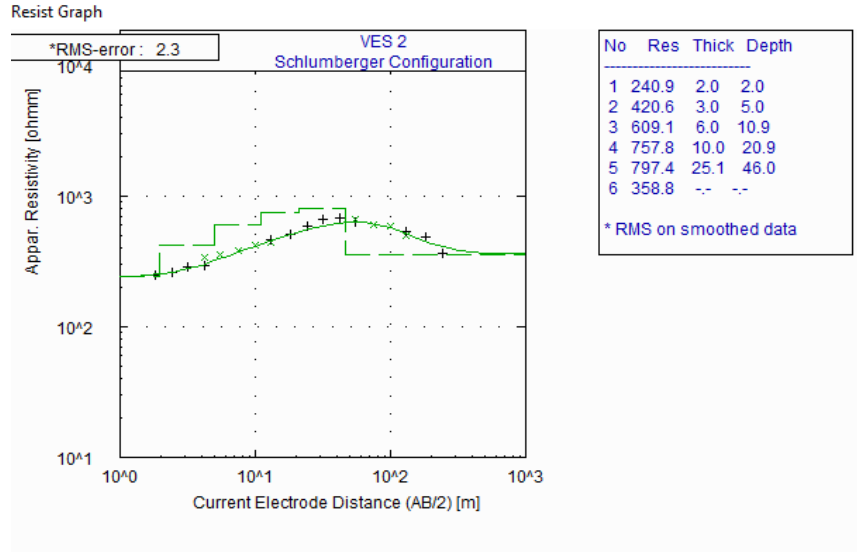
The traverse reveals a resistivity distribution ranging between 240.9 Ω and 797.4 Ω (see Figure 4.6). Figure 4.6 also reveals the number of layers present in the subsurface as well as the resistivity, thickness, and depth of each layer. Six (6) layers were discovered, and the fifth layer was mapped out to be at a depth of 46.0 m. The type of curve for this profile is Type K.

Figure 4.6: VES 2 Profile (Goelectric-section for VES 2)

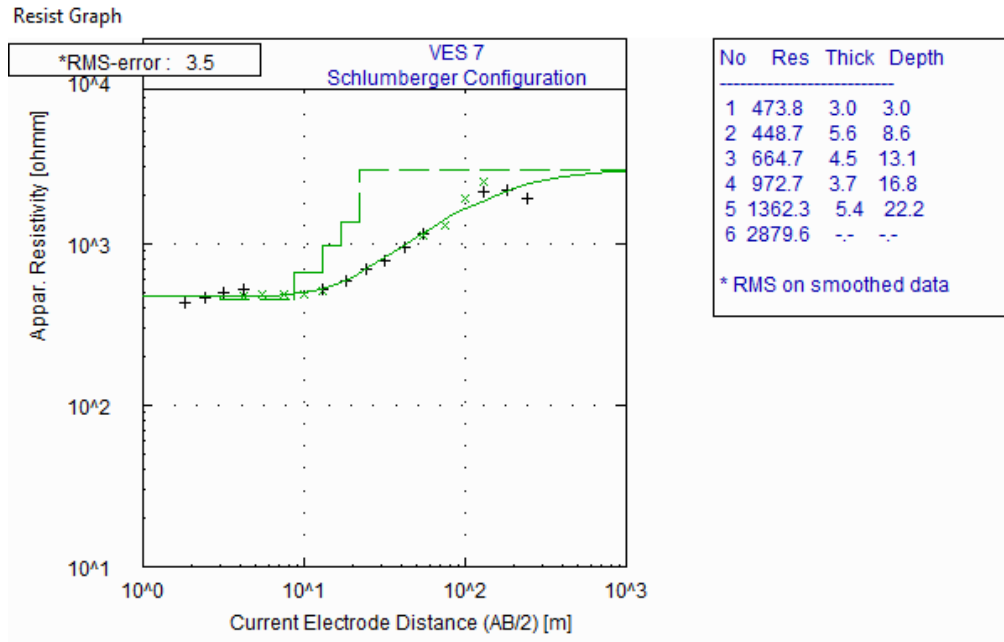
The traverse reveals a resistivity distribution ranging between 473.8 Ω and 2879.6 Ω (see Figure 4.11). Figure 4.11 also reveals the number of layers present in the subsurface as well as the resistivity, thickness, and depth of each layer. Six (6) layers were discovered, and the fifth layer was mapped out to be at a depth of 22.6 m. The type of curve for this profile is Type A.

Figure 4.11: VES 7 Profile (Goelectric-section for VES 7)

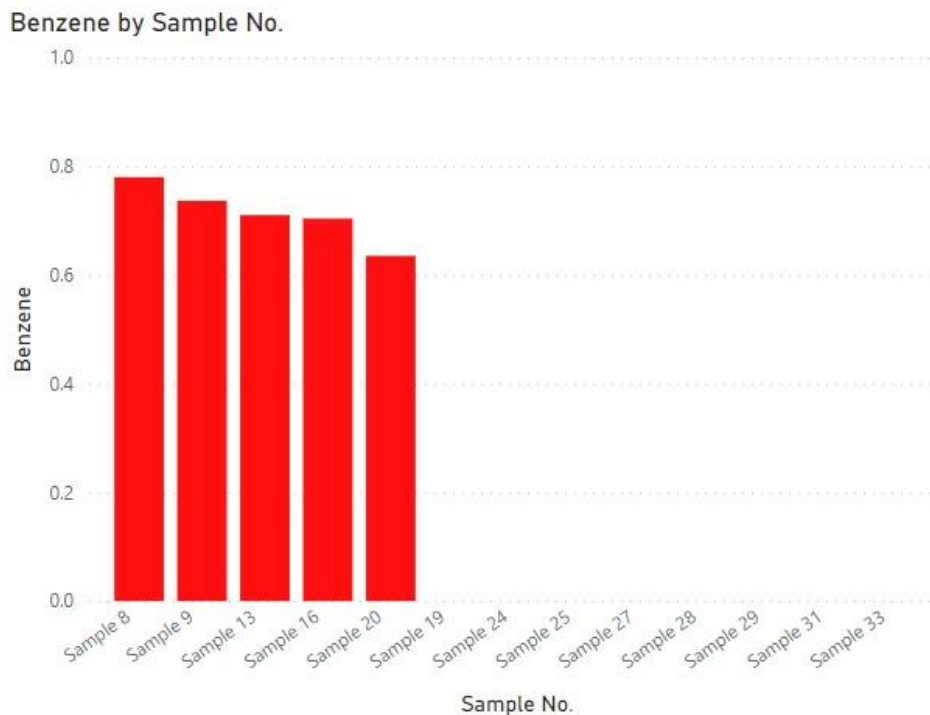
The concentration of Benzene in all the samples analyzed ranged between 0-0.78 mg/L. Sample 8 had the highest concentration of Benzene 0.78, followed by Sample 9, Sample 13, 16 and 20 (see Figure 4.13). The result of the analysis also showed that majority of the water sources in the study area had concentration levels of Benzene that exceed the acceptable limits of WHO (0.01 mg/L) (see Table 4.4) and US EPA (0.005 mg/L) (see Table 4.3) and as such residents are exposed to certain health risks. Short term exposure to concentration levels of Benzene that exceed acceptable limits are known to cause irritation of the eyes, skin, and upper respiratory as well as blisters on the skin. While a longer exposure may result in blood diseases, reproductive and developmental problems, and cancer (Garang Kuch & Bavumiragira, 2019).

Figure 4.13: Concentration of Benzene for certain water samples

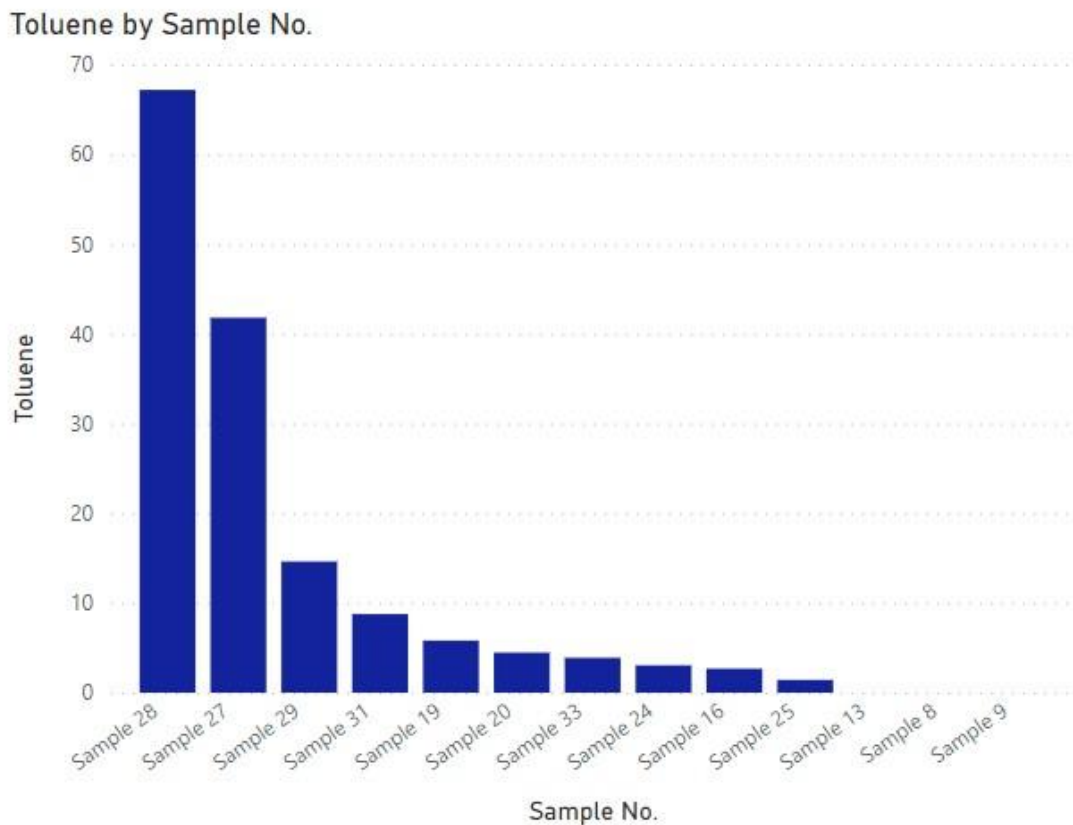
The concentration of Toluene in all the samples analyzed ranged between 0-67.19 mg/L. Sample 28 had the highest concentration (67.19 mg/L), followed by Sample 27 and Sample 29 (see Figure 4.14). Figure 4.14 also reveals that the water samples had a Toluene concentration that exceeds the WHO (see Table 4.4) and US EPA (see Table 4.3) standard that should be found in drinking water. Consuming water with such levels of Toluene may have an impact on the nerve system, irritate the skin, eyes, and respiratory tract, and result in birth defects, headaches, dizziness, and difficulties sleeping (Garang Kuch & Bavumiragira, 2019).

Figure 4.14: Concentration of Toluene for certain water samples

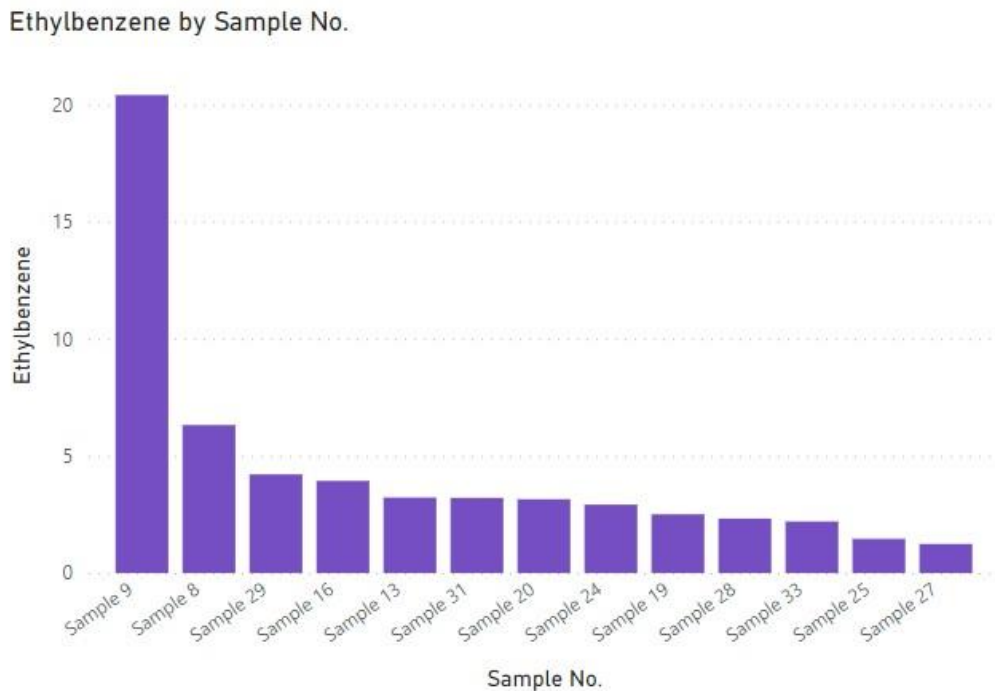
The concentration of Ethylbenzene in all the samples analyzed ranged between 0-20.41 mg/L. Particularly, for the 13 samples with high concentration of BTEX, sample 9 had the highest Ethylbenzene concentration (20.41 mg/L) and was 1,543.44% higher than Sample 27, which had the lowest Ethylbenzene at 1.24 mg/L (see Figure 4.15). As Figure 4.15 reveals, the water samples contain concentration levels of Ethylbenzene that lie above the acceptable limits to be found in drinking water by the WHO (Table 4.4) and US EPA (see Table 4.3). The implication of this includes throat and eye irritation, dizziness, chest constriction and may even result in blood disorder if consumption continues over time (Garang Kuch & Bavumiragira, 2019).

Figure 4.15: Concentration of Ethylbenzene for certain water samples

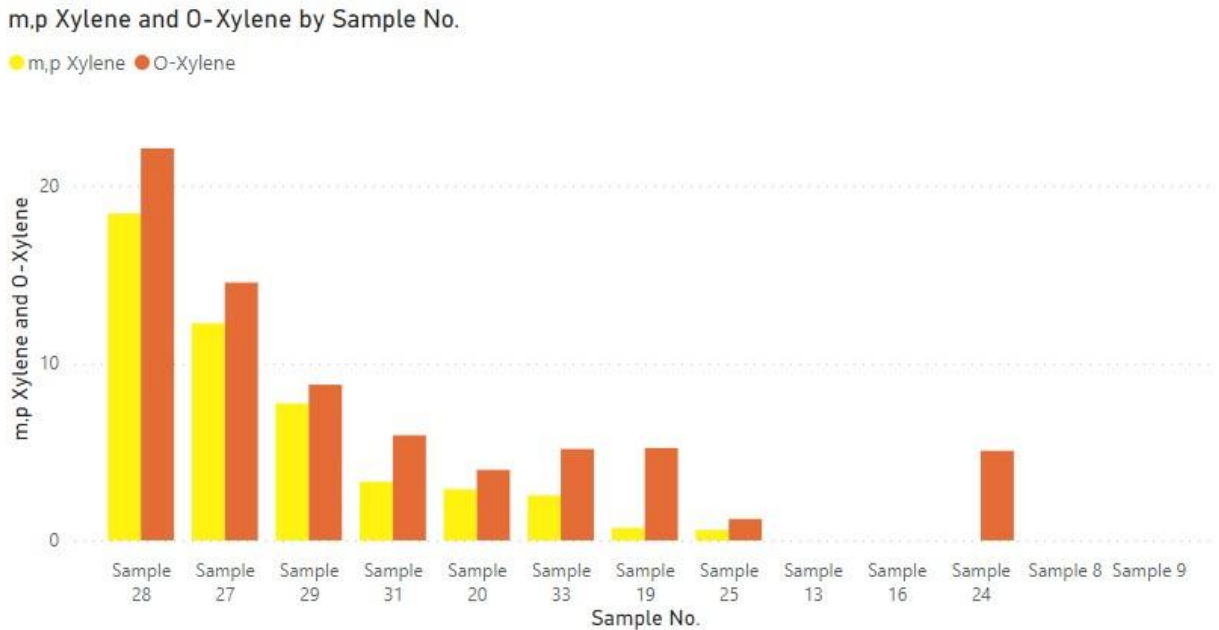
The concentration of Xylenes in the analyzed water samples ranged between 0 and 18.43 mg/L (m, p Xylene) and 22.11 mg/L (O-Xylene). In Figure 4.16, the concentrations of m, p Xylene and O-Xylene are shown for the 13 water samples with high BTEX concentrations. Sample 28 showed the highest concentration of both m, p Xylene and O-Xylene (see Figure 4.16). A good number of the water samples were discovered to have Xylene concentrations beyond the acceptable limits by WHO (see Table 4.4) and US EPA (see Table 4.3). Exposure to high concentrations of xylenes over a short period of time may result in neurological symptoms, nausea, vomiting, stomach irritation, moderate transitory ocular irritation, and effects on the nose and throat. The neurological system may be harmed by prolonged exposure to high doses of xylene (Garang Kuch & Bavumiragira, 2019).

Figure 4.16: Concentration of m, p Xylene, and O-Xylene for certain water samples

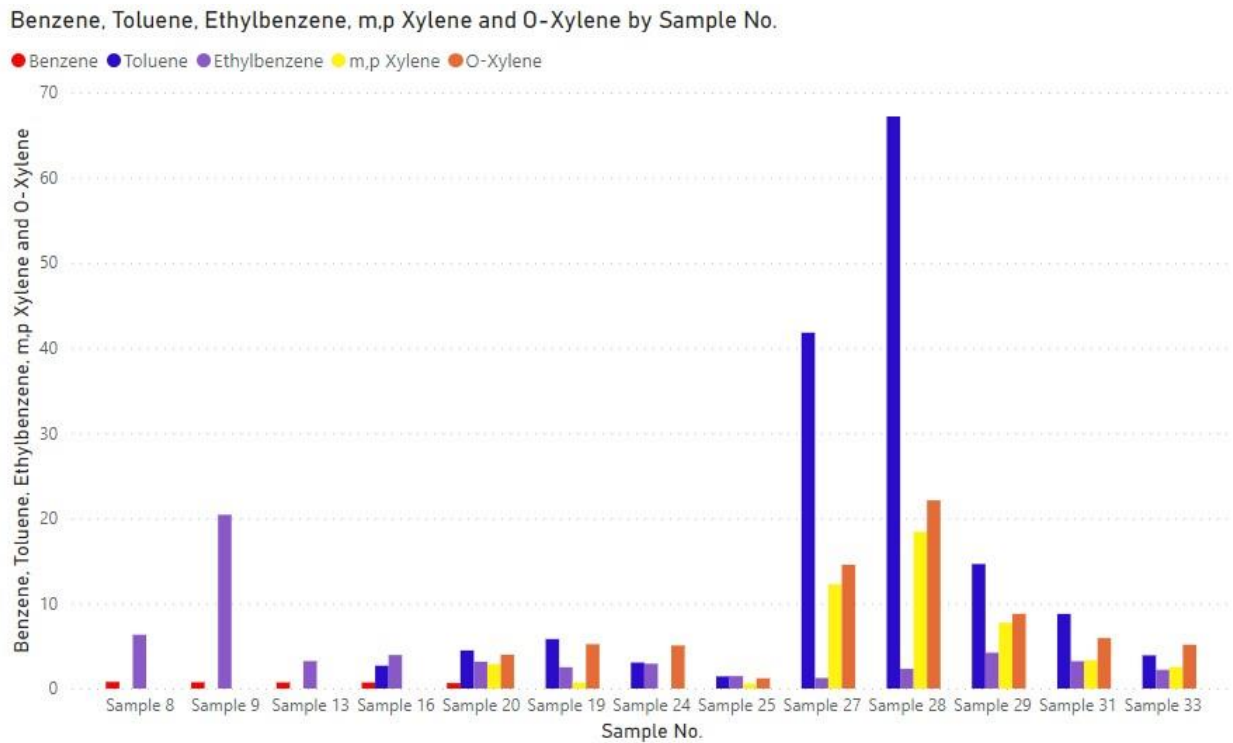
Across the 13 water samples with showed significantly high concentrations of BTEX, Toluene appeared to be the compound with the highest concentration (Sample 28) followed by O-Xylene (Sample 28), then Ethylbenzene (Sample 9), and m, p Xylene (Sample 28). Benzene has the lowest concentration throughout all the samples analyzed (see Figure 4.17). However, seeing that the maximum concentration level for Benzene accepted in drinking water is rather low (0.005 mg/L by US EPA and 0.01 by WHO) most of the water sources are considered very harmful to the health of residents. Water sources from which Samples 8, 9, 13, 16, 20, 28, 27, and 29 are particularly very harmful to residents who utilize them as the concentration of BTEX in them are found to be the highest out of all 34 samples analyzed.

Figure 4.17: Chart showing BTEX concentration levels in analyzed water samples

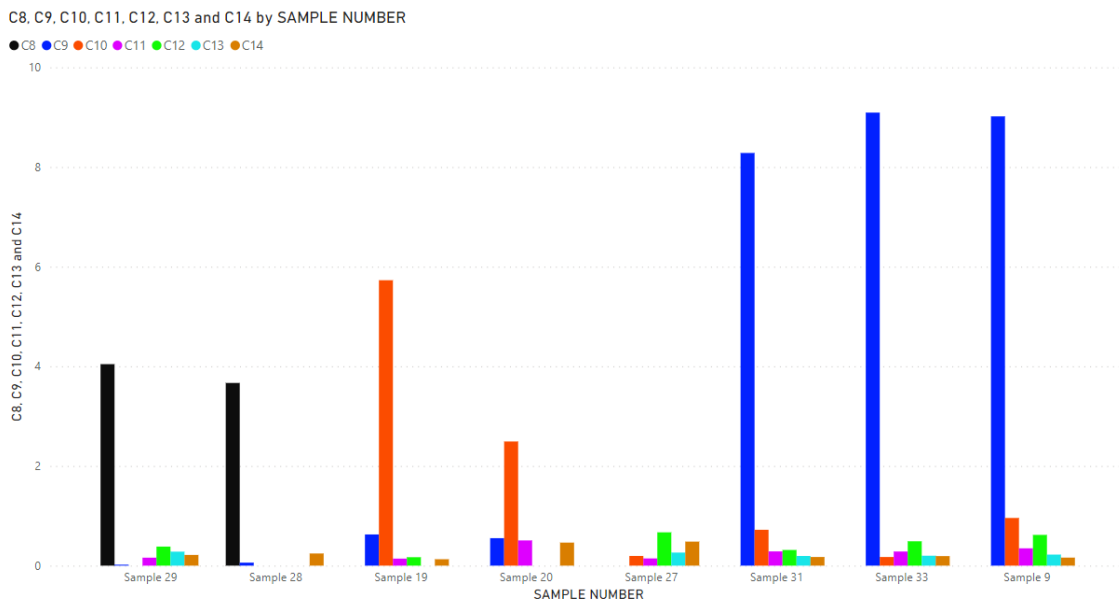
The second compound with the highest concentration levels was C10 (Sample 19) followed by C8 (Sample 29).

Figure 4.18: Concentration levels of C8-C14 in analyzed water samples

The result of the GC-MS as shown in Figure 4.18-Figure 4.21, reveals that the hydrocarbons present in the water samples are C8-C30. However, the more predominant hydrocarbons were C8-C10, C16-C18 and C27-C30. Figure 2.2 indicates that the likely source of these hydrocarbons include gasoline, Kerosene, fuel oil and lubricating oils. Corroborating the results from the VOC analysis (see Figure 4.13-Figure 4.17) and the TPH analysis (Figure 4.18-Figure 4.21) indicates that the presence of BTEX chemical components, precisely Toluene, is likely to be from gasoline. The significant presence of C16-C18 will be from Kerosene and C27-C30 from fuel oil and lubricating oils. Thus, the groundwater aquifers in the study area are contaminated with significant concentration levels of BTEX as well as hydrocarbons components from Kerosene, fuel oil and lubricating oils.

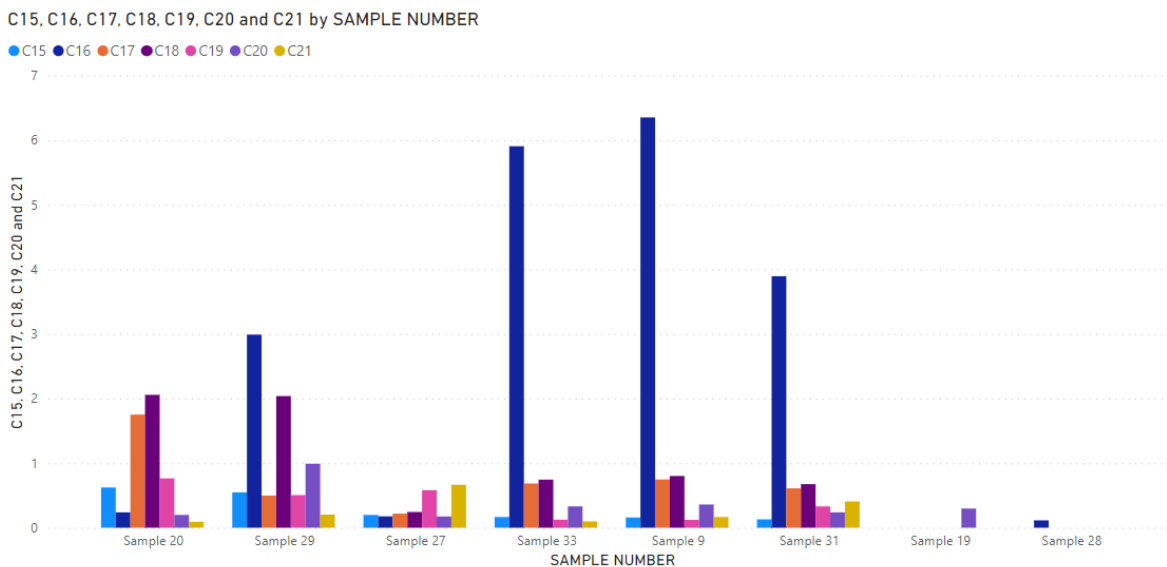
Figure 4.19 reveals the concentration levels for C15-C21 in which C16 had the highest concentration (6.35250 mg/L in Sample 9). This is followed by the concentration of C18 and C17 in Sample 20.

Figure 4.19: Concentration levels of C15-C21 in analyzed water samples

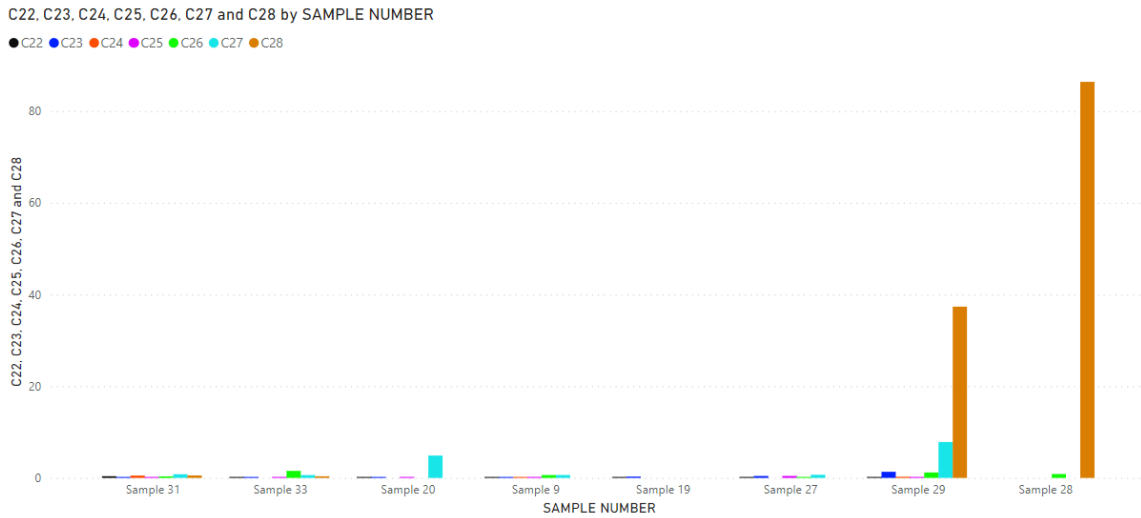
Moreover, C28 is the compound with the highest concentration level across all the petroleum-related hydrocarbons analyzed in the water samples with a concentration level of 86.39102 mg/L in Sample 28 (see Figure 4.20). High concentration levels of C28 are also noticed in Sample 29 (Figure 4.20).

Figure 4.20: Concentration levels of C22-C28 in analyzed water samples

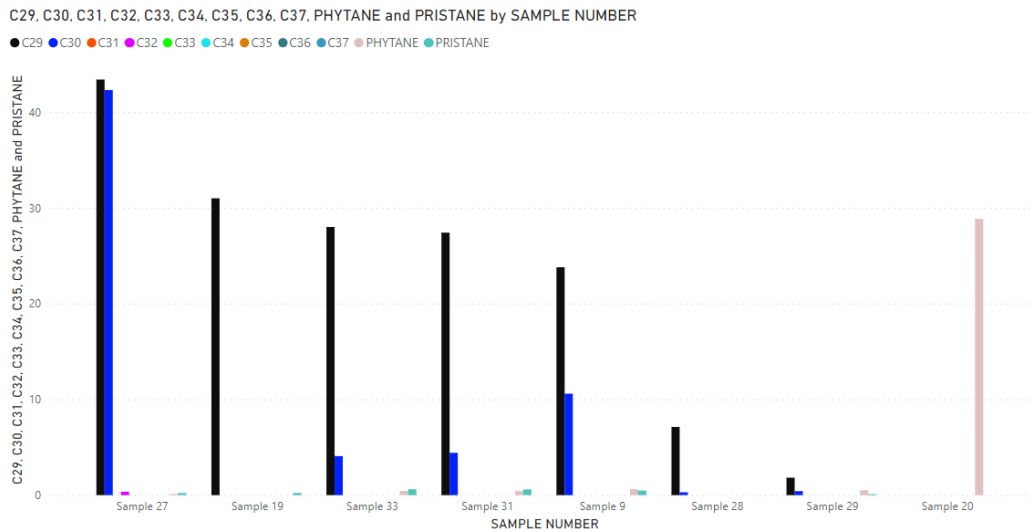
For Carbon fractions ranging between C29-C37, C29 had the highest concentration level of 43.40090 mg/L in Sample 27, followed by C30 with concentration levels of 42.30175 mg/L still found in Sample 27 (see Figure 4.21).

Figure 4.21: Concentration levels of C29-C37, Phytane and Pristane in analyzed water samples
